CITY OF DALLAS

DATE January 15, 2010

SUBJECT **Periodic Inspection Report No. 9
Maintenance Deficiency Correction Period (MDCP) December 2009 Update**

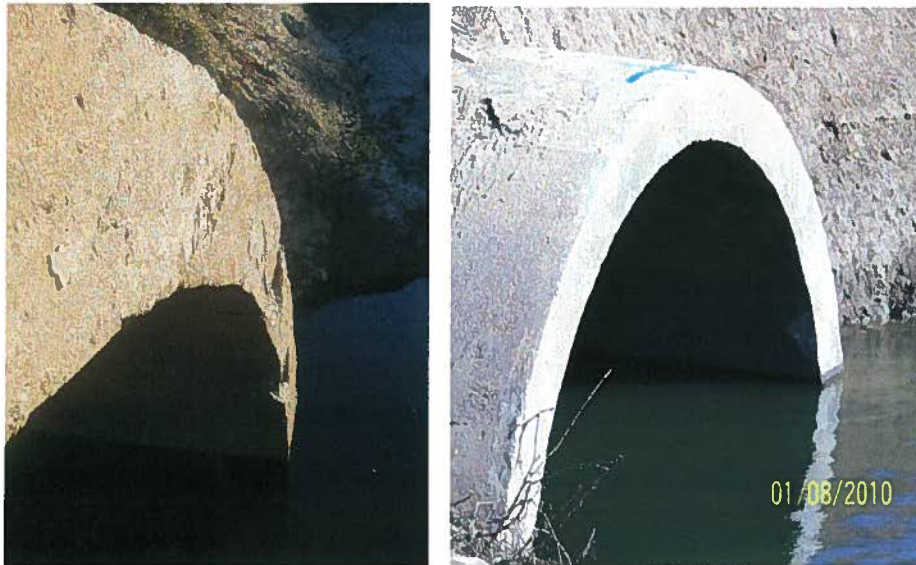
1.1.1 Corps. ID Nos. 042 and 236 – Belleview Pressure Conduit, East Levee – These two “Obs” items referred to the same issue of damage to the concrete around the perimeter of the outlet.

1.1 Five of the addressed items involved concrete repair of spalling, damaged or scouring concrete. The concrete was repaired by chipping away any loose concrete, sealing exposed rebar, then patching the concrete with a cementitious material.

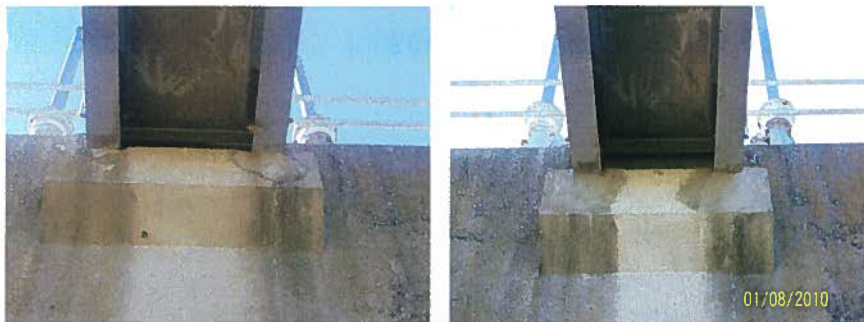
1.1.2 Corps. ID No. 097 – Baker Pump Station, East Levee – This “M” item noted a spall under the bridge support at the control structure.
