Memorandum

CITY OF DALLAS

DATE February 10, 2010

SUBJECT **Periodic Inspection Report No. 9**
Maintenance Deficiency Correction Period (MDCP) January 2010 Update

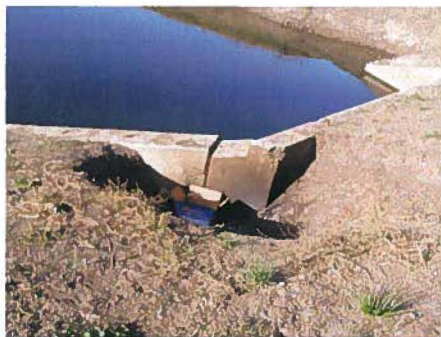
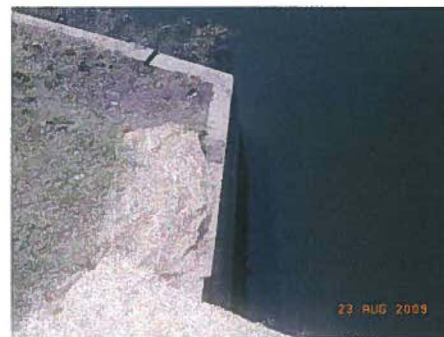
- 1.1.1 Corps. ID Nos. 059 and 060 – Turtle Creek Pressure Sewer, East Levee – Sta. 194+13 had left discharge failing wing wall displaced 3 inches with erosion behind it (5'W x 4'L x 3'D) the offset between the headwall and wing wall appears to be getting worse over time. A second wall joint had separated by 2 inches and moved channel ward by ¼ inch relative wing wall.

The erosion behind the wing wall was repaired. The joints in the wingwall were replaced the separation was inspected and determined to not be a structural issue. The joints will be monitored for further displacement and addressed if necessary.

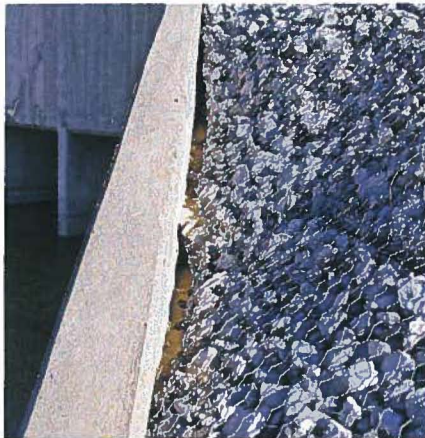
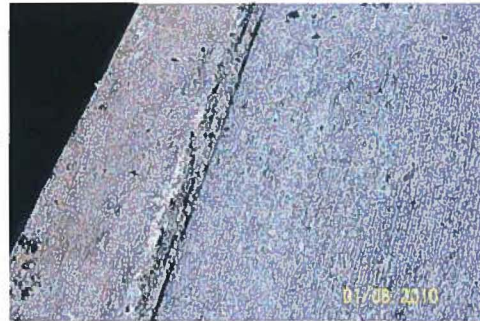
- 1.2 Corps. ID No. 220 – Rochester Gravity Structure, Rochester Levee – This “U” item indicated Sta. 89+00 had intake gravity flow structure that had depressions on the gabion slopes on both sides of the intake caused by erosion of soil material under the gabions next to the wing walls. The right side had a 2 foot deep gully next to the wing wall (exposed/washing out of bedding) and the left side has a 18'L x 10'W area depression on the gabion slope next to the wing wall.

The gabion structure was removed, the depression repaired and the slope paved.

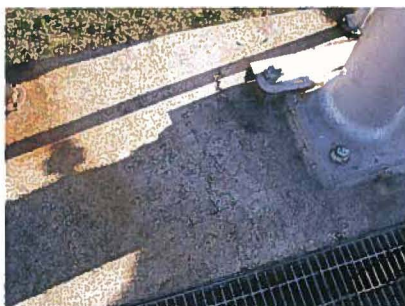
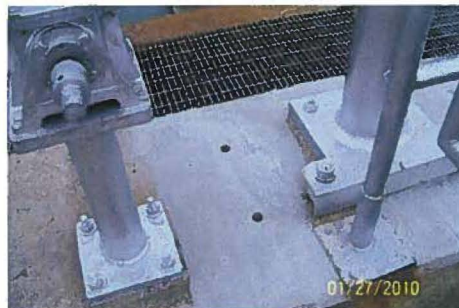
- 1.4.1 Corps. ID No. 068 – Dallas Branch Pressure Conduit, East Levee – Replacement of rusted bolts at the base of the stem for the right gate operator appears to have caused cracking in the concrete deck. The crack allows freeze/thaw damage.

- 1.4 Five of the addressed “M” items involved concrete repair. The items were repaired by either injecting epoxy sealant into cracks and/or chipping away loose concrete and repairing with a cementitious material.

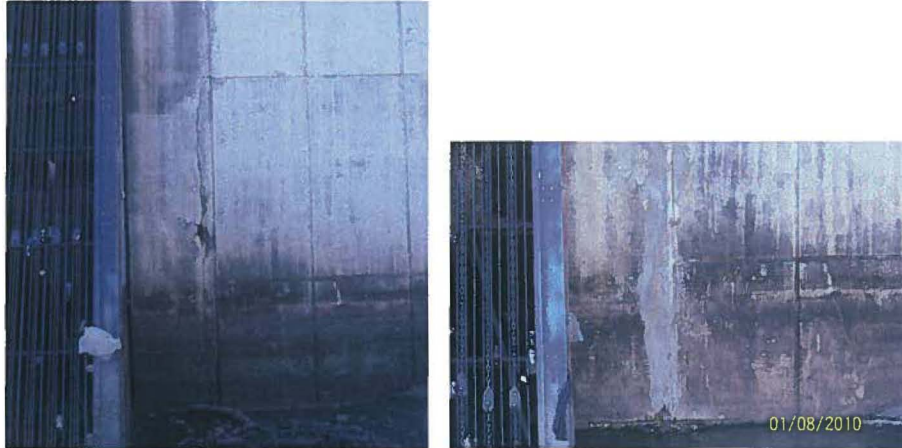
- 1.4.2 Corps. ID No. 099 – New Baker Pump House, East Levee – Cracking and spalling of the concrete panels at both the right and left side of the trash rack.

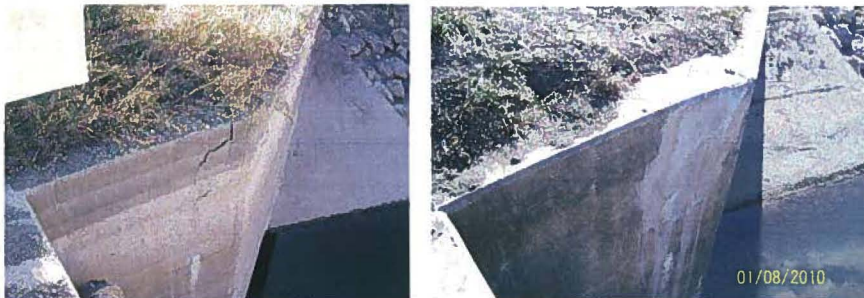
- 1.4.4 Corps. ID No. 107 – Woodall Rodgers Pressure Outfall, East Levee – The concrete was cracked at the corners of the wing walls at the discharge basin.

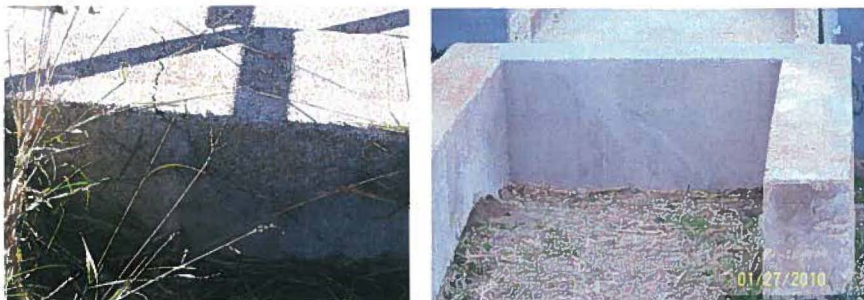
- 1.4.5 Corps. ID No. 181 – Little Coombs Creek Conduit, West Levee – Service bridge abutment had moderate cracking.
