# Memorandum

CITY OF DALLAS

SUBJECT **Periodic Inspection Report No. 9  
Maintenance Deficiency Correction Period (MDCP) August 2009 Update**

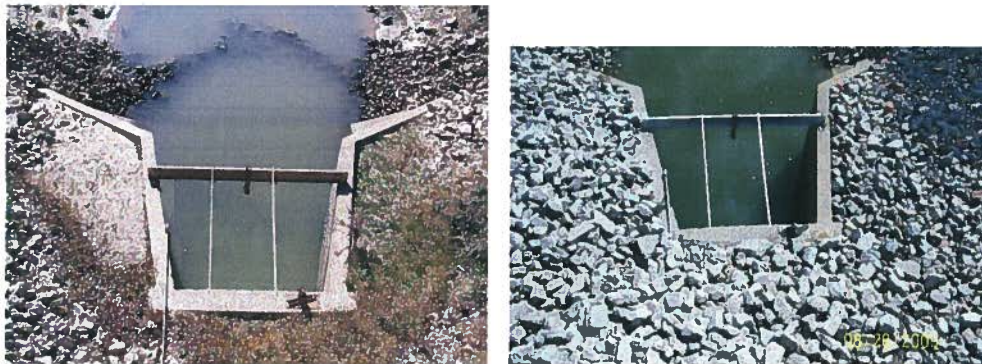
- 1.1 Corps. ID No. 073/089 – New Hampton Pump Station, East Levee – Riprap displaced from the slopes of the discharge chute to the bottom of the channel, exposing bedding.

The riprap was removed, the slope repaired and the riprap replaced.

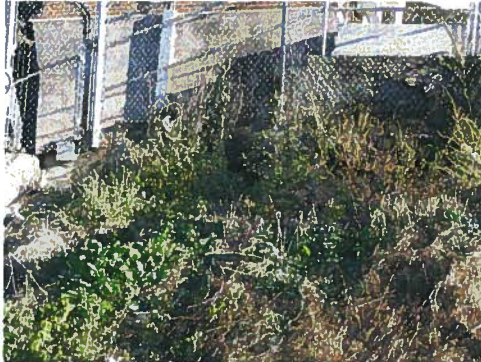
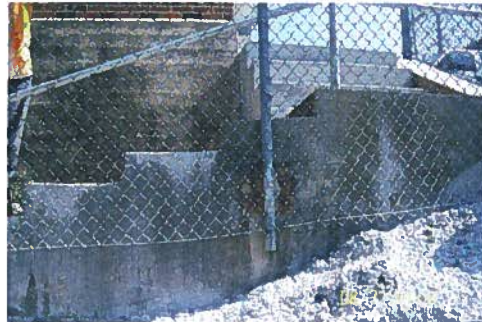
- 1.2 Corps. ID No. 175 – Charlie Pump Station, West Levee – There was an erosion void under the stairs next to the pump house on the west side of the building. It was unclear how far back the void goes.

The source of erosion was identified and the void was repaired and filled using established levee repair procedures.

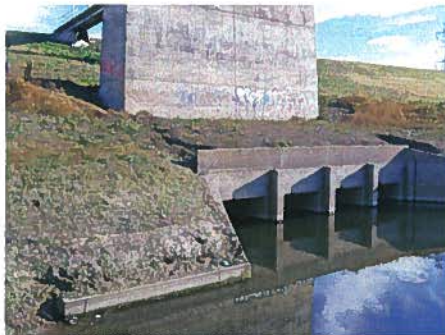
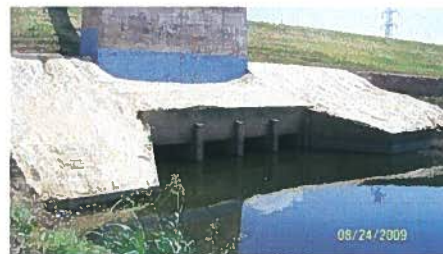
1.3.1 Corps. ID No. 063 – Turtle Creek Pressure Sewer, East Levee – There is erosion on both the right and left slope just above the corners of the discharge chute.

1.3 Nine of the addressed “M” (Minimally Acceptable) items fall into the category of erosion of slope or slides. These were all repaired using established levee slide repair procedures.

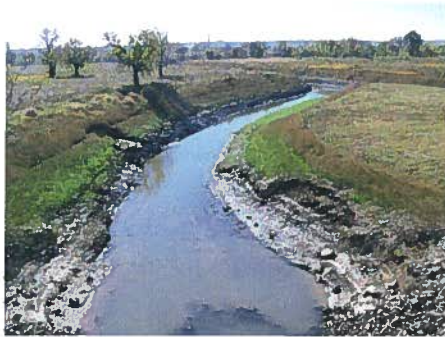
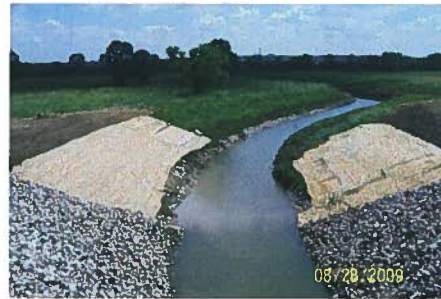
1.3.2 Corps. ID No. 074 – Hampton Pump Station, East Levee – There are slides on the right and left slopes downstream of the displaced riprap.

This item was repaired concurrently with the items in paragraph 2.1 and is further illustrated in the photos below.

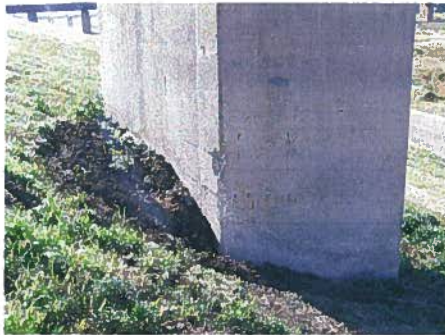
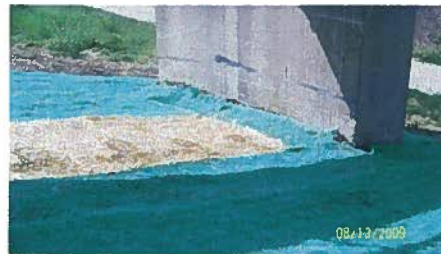
1.3.3 Corps. ID No. 106 – Dallas Branch Pressure Sewer, East Levee – There is a 12 inch erosion depression on the down slope side of the service bridge abutment and a six inch erosion depression on the right side of the control structure on the levee.

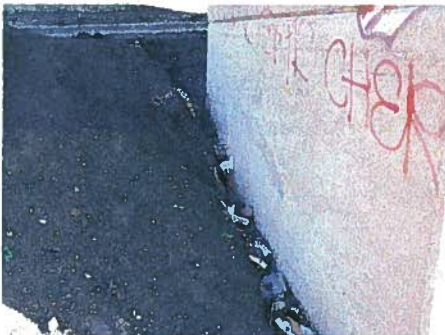
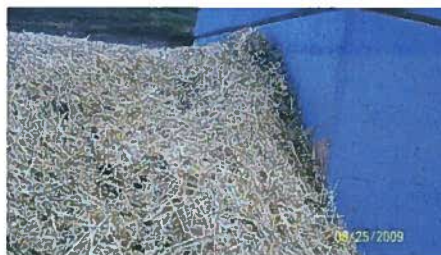
1.3.4 Corps. ID No. 109 – Turtle Creek Pressure Sewer, East Levee – There is erosion (6'W x 6' L x 6' D) on the right side of the control structure.

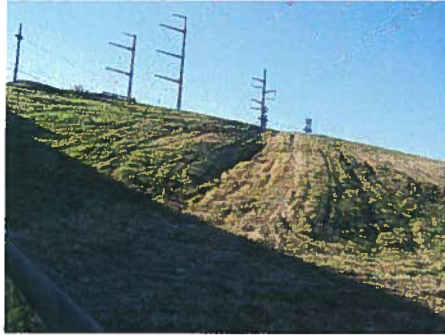
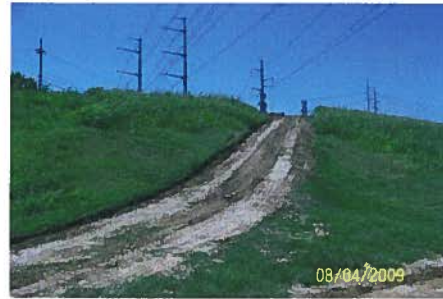
- 1.3.5 Corps. ID No. 143 – Station 134+20, West Levee – There is a 20 foot long erosion gully on the river side levee ramp.

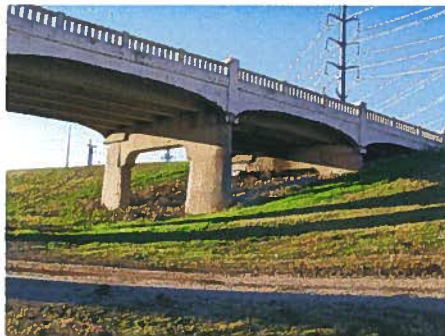
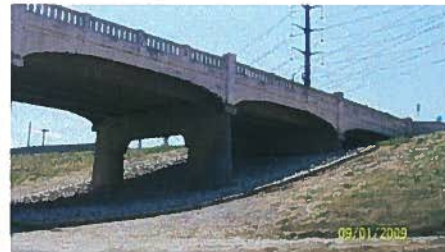
- 1.3.6 Corps. ID No. 150 – Continental Avenue Bridge, West Levee – There is a depression in the riverside riprap slope under the bridge.

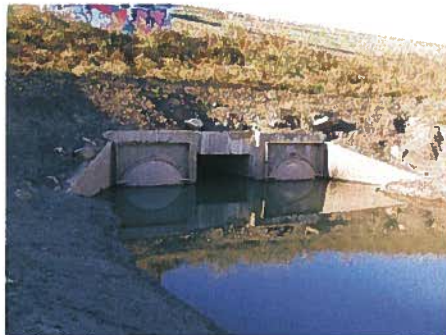
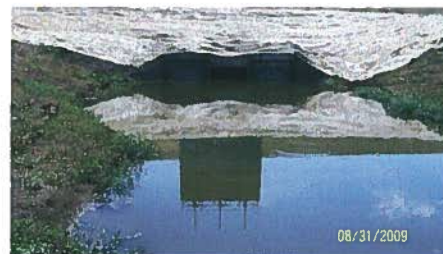
- 1.3.7 Corps. ID No. 168 – Lake Cliff Pressure Conduit, West Levee – There is erosion above the discharge chute (8'W x 40'L).

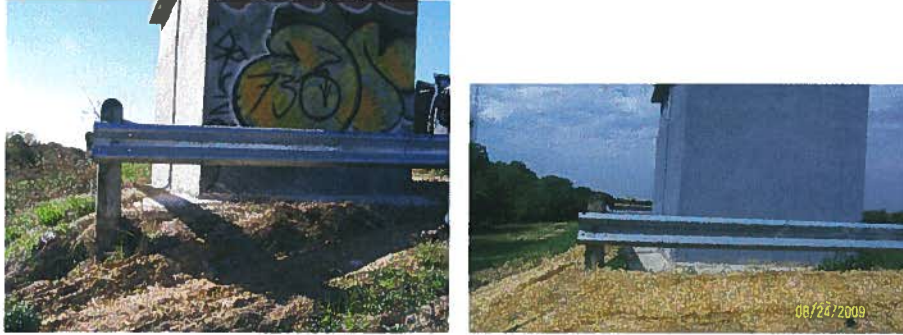
- 1.3.8 Corps ID No. 186 – Eagle Ford Sluice Gate, West Levee – There is an erosion gully (6"W x 3'L x 1'D) next to the landside upstream corner of the control structure which had undermined corner post of guardrail.

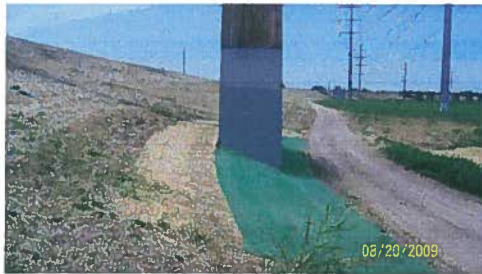
- 1.3.9 Corps. ID No. 229 – Lake Cliff Pressure Conduit, West Levee – There is a six inch erosion depression on the down slope side of the service bridge abutment on the levee. There is not a before photograph available at this location, see after photo below.

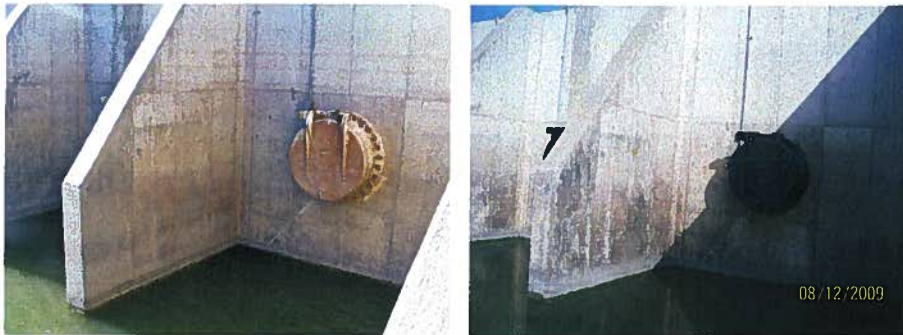
1.4.3 Corps. ID No. 215/219 – Rochester Pump Station, Rochester Levee – Rust on pump station flap gates and walkway.

Below are before and after photos of the rust treatment at the Rochester Pump Station

1.4 Four "M" (Minimally Acceptable) items, two of which are at the same location, were addressed during August 2009 by neutralizing rust and painting of metallic parts.

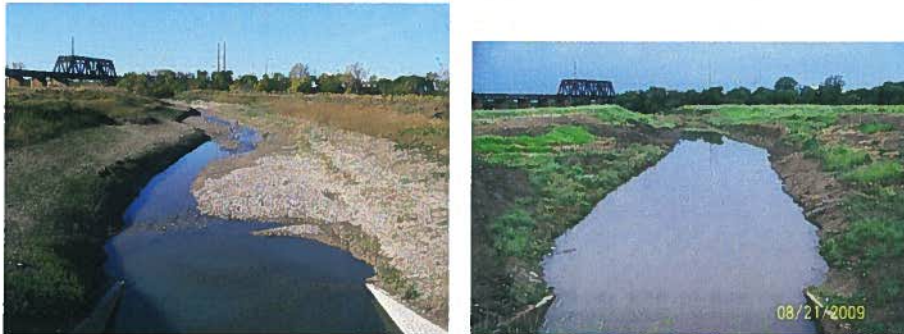
1.5.1 Corps. ID No. 047 – Dallas Branch Pressure Conduit, East Levee – There is deposition of 70% on the right side of the discharge channel.

Photos of the de-silted channel are shown below.

1.5 Two "M" (Minimally Acceptable) items were addressed by de-silting the channels.

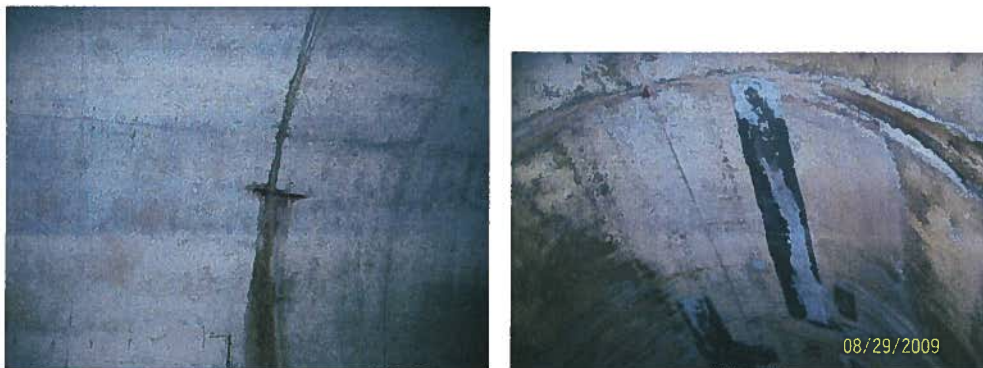
1.6 Corps. ID No. 159 – Big Coombs Creek Pressure Conduit, West Levee – This "M" item involved exposed steel reinforcement in the ceiling and cracking in the floor and wall. This was repaired by chipping out all of the loose concrete around and behind the exposed steel and cracks, then patching using an engineer approved sealant. Below are before and after photos at the Big Coombs Creek Pressure Conduit.

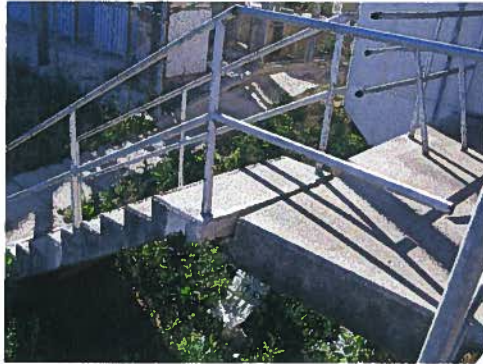
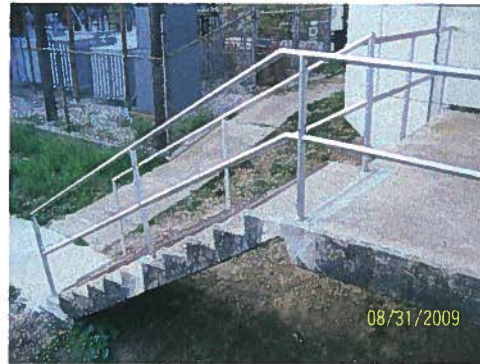
- 1.7 Corps. ID No. 104 – Baker Pump Station, East Levee – This “M” item notes that the hand rails at the top of the stairs behind the building are broken.  
The handrail was removed and replaced.

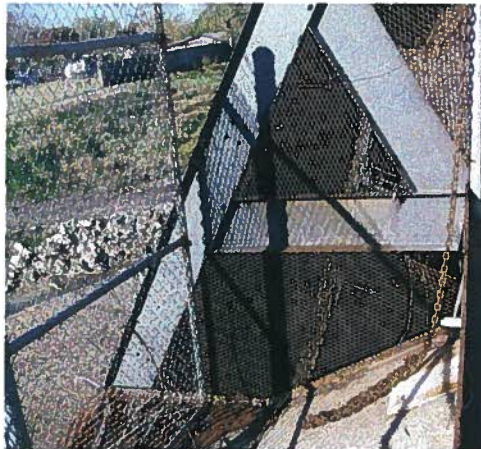
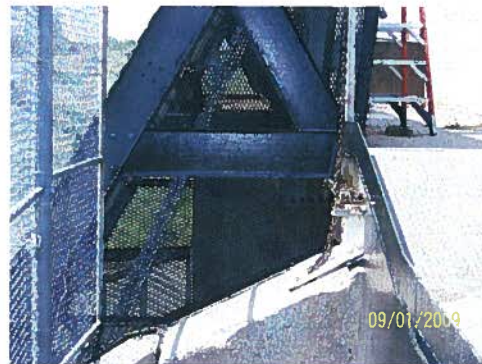
- 1.8 Corps. ID No. 238 – Pavaho Pump Station, West Levee – This item indicates there is 5"W x 8"L tear in the right side rail screen.
