# **White Rock & Bachman Dam and Spillway Engineering Design Improvements**

Briefing for  
Quality of Life Committee  
June 26, 2006

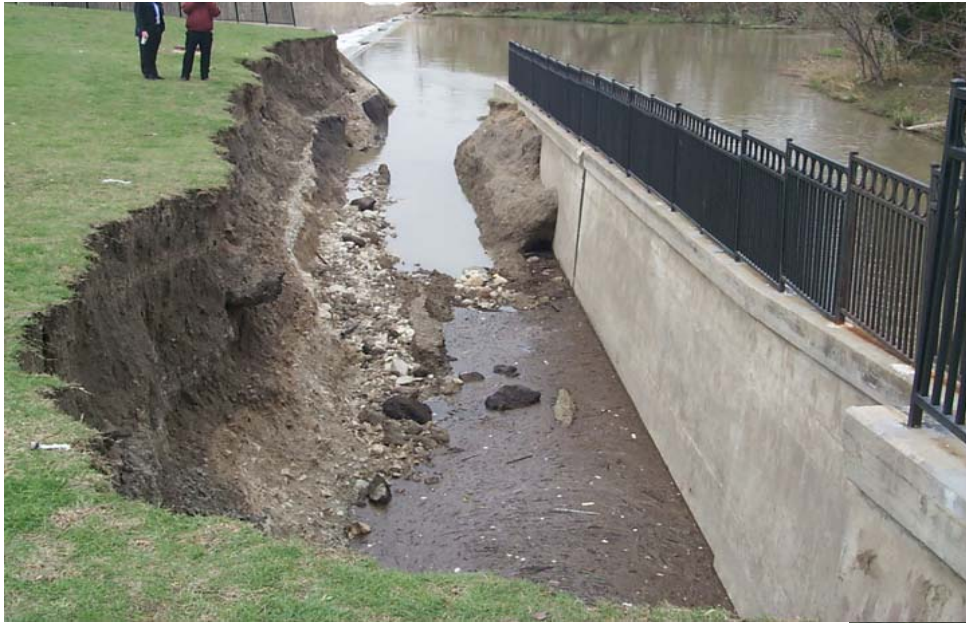
Retaining wall sliding failure on south side of the Spillway

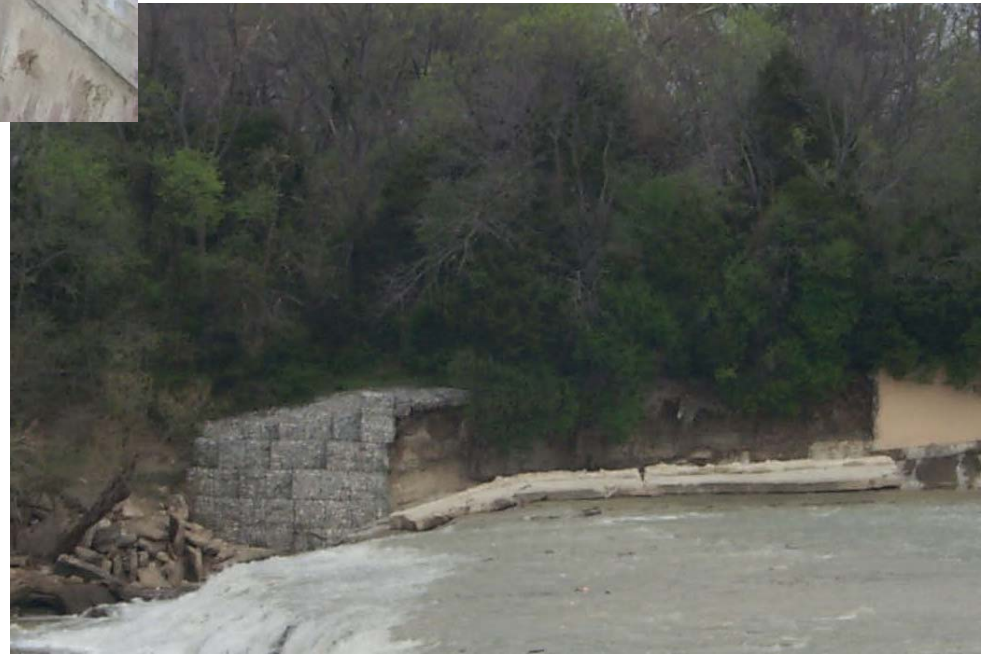
Retaining wall shear failure on north side of the Spillway

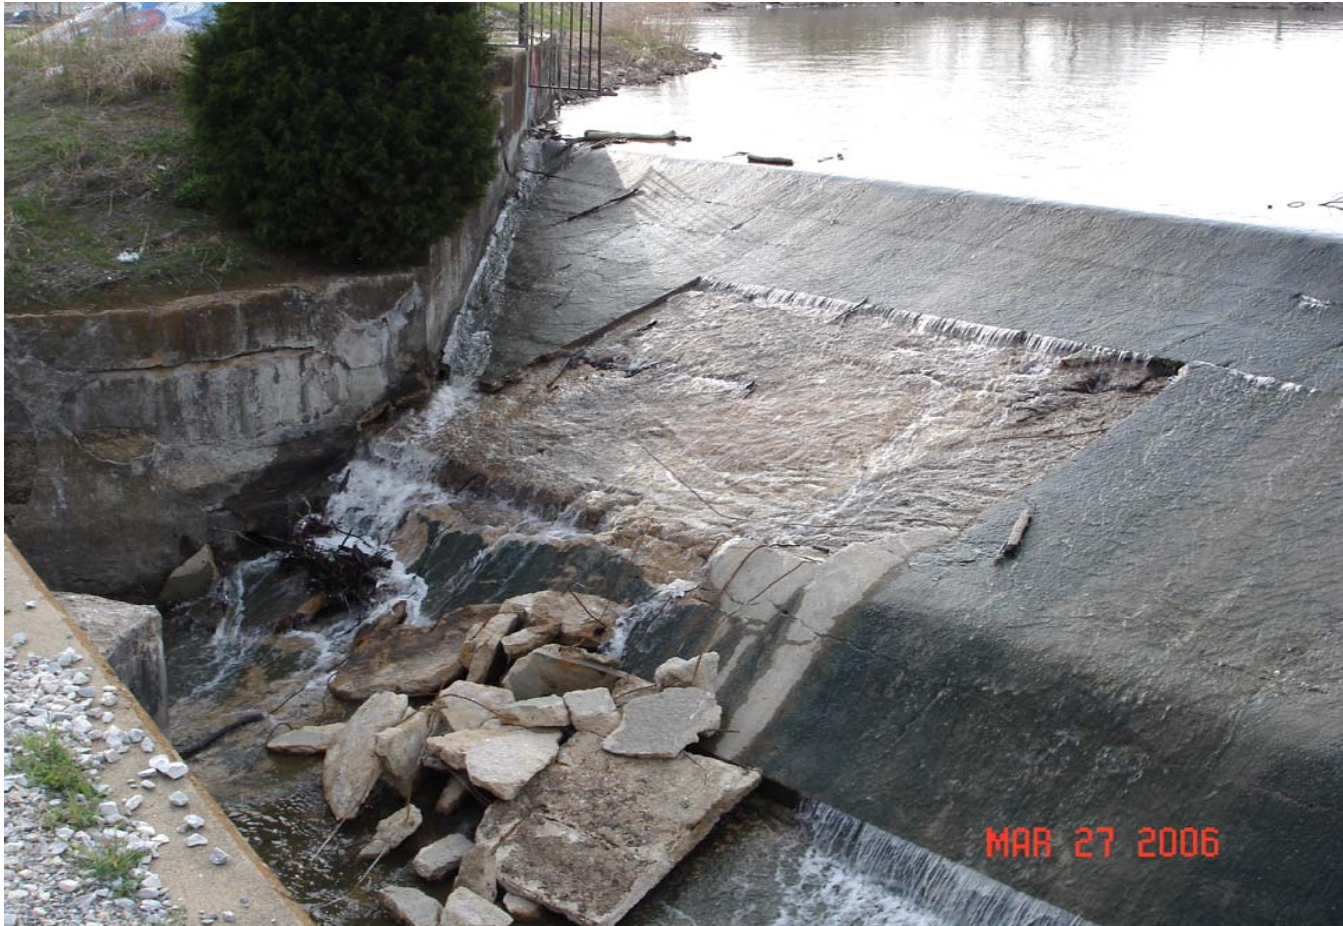
Damaged incurred during the storm in mid-March 2006

- Bachman Dam is located on a tributary of the Elm Fork of the Trinity River and created the reservoir known as Bachman Lake
- Primary structures include uncontrolled concrete ogee weir and an earthen embankment built in 1901
- Results of the 2003 inspection identified the critical need for spillway reconstruction and upstream slope stability protection
- Two past episodes of emergency repairs made to the dam and spillway structure, including grouting voids under the concrete weir service spillway
- Most recently, the large rain event in mid-March 2006 caused damage to the service spillway, as shown in the following photograph, that if left unchecked will further erode endangering property down stream from the dam
